Additional Noise Suppression on pE-100

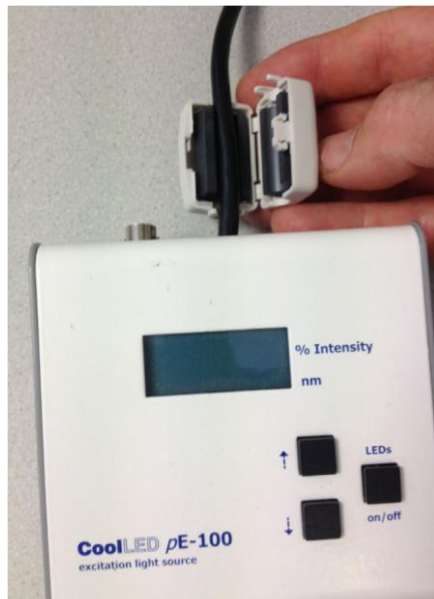
Place split core ferrite around

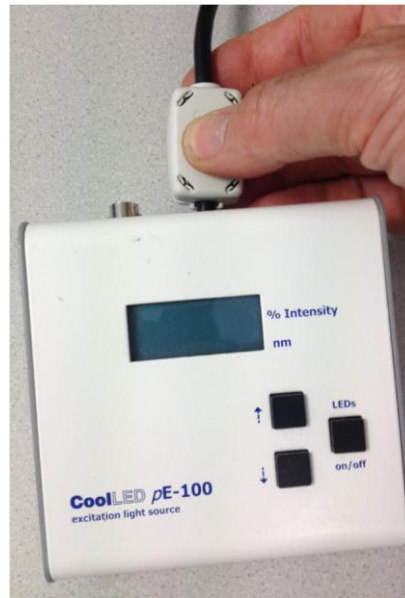
Snap shut

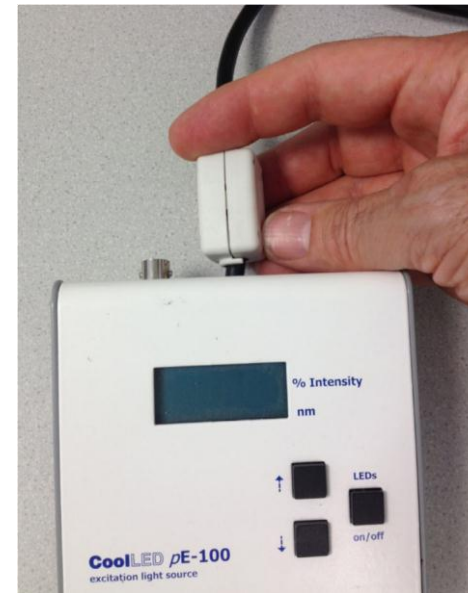
Ensure 2 halves are
clipped together cable close to the pod
